Kielty Arborist Services LLC

April 10, 2019

Site: Carpenters Center, 18640 Madrone Parkway, Morgan Hill CA

As requested on Friday, March 15, 2019, I visited the above site for the purpose of inspecting and commenting on the trees. Development is proposed on this lot consisting of a new carpenters training center and parking lot. Site plan A1.0 dated 1/28/19 and landscape plans L1-L3 were reviewed for writing this report. Your concerns as to the future health and safety of the trees on site has prompted this report.

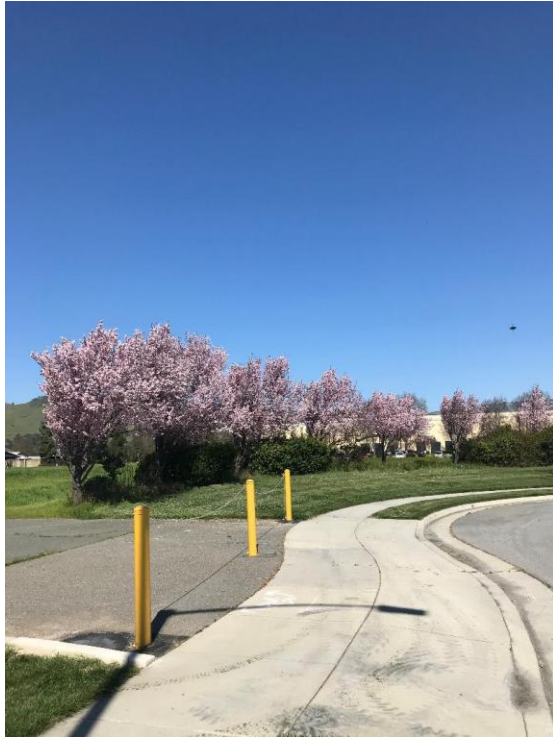
Tree#	Species	DBH	CON	HT/SP	Comments
1	Purple leaf plum (<i>Prunus cerasifera</i>)	6.1	40	10/10	Fair vigor, poor form, heavy decay on trunk, sunscald.
2P	Tulip tree (<i>Liriodendron tulipifera</i>)	11.3	30	35/15	Fair vigor, fair form, decay/damage at roots from lawn mower, decay to 3 feet.
3P	Tulip tree (<i>Liriodendron tulipifera</i>)	8.2	60	35/15	Fair vigor, fair form, damage to roots from lawn mower in past.
4	Purple leaf plum (<i>Prunus cerasifera</i>)	8.2	60	18/12	Fair vigor, fair form, abundance of sprout growth.
5	Purple leaf plum (<i>Prunus cerasifera</i>)	3.2	60	14/6	Fair vigor, fair form, young tree.
6	Purple leaf plum (<i>Prunus cerasifera</i>)	5.8	60	12/12	Fair vigor, fair form, minor sunscald.
7	Purple leaf plum (<i>Prunus cerasifera</i>)	7.0	65	12/12	Fair vigor, fair form.
8	Purple leaf plum (<i>Prunus cerasifera</i>)	7.2	65	14/10	Fair vigor, fair form, sprout growth.
9	Purple leaf plum (<i>Prunus cerasifera</i>)	8.0	65	14/10	Fair vigor, fair form, sprout growth.

10	Purple leaf plum (<i>Prunus cerasifera</i>)	8.7	65	14/10	Fair vigor, fair form, sprout growth.
11	Purple leaf plum (<i>Prunus cerasifera</i>)	8.5	65	14/10	Fair vigor, fair form, sprout growth.
12	Purple leaf plum (<i>Prunus cerasifera</i>)	8.3	65	14/10	Fair vigor, fair form, sprout growth.
13P	Tulip tree (<i>Liriodendron tulipifera</i>)	13.1	50	45/12	Fair vigor, fair form, damage to buttress roots from lawn mower.
14	Tulip tree (<i>Liriodendron tulipifera</i>)	9.2	45	30/12	Fair vigor, poor form, decay on trunk near grade, lawn mower damage.

Showing purple leaf plum trees

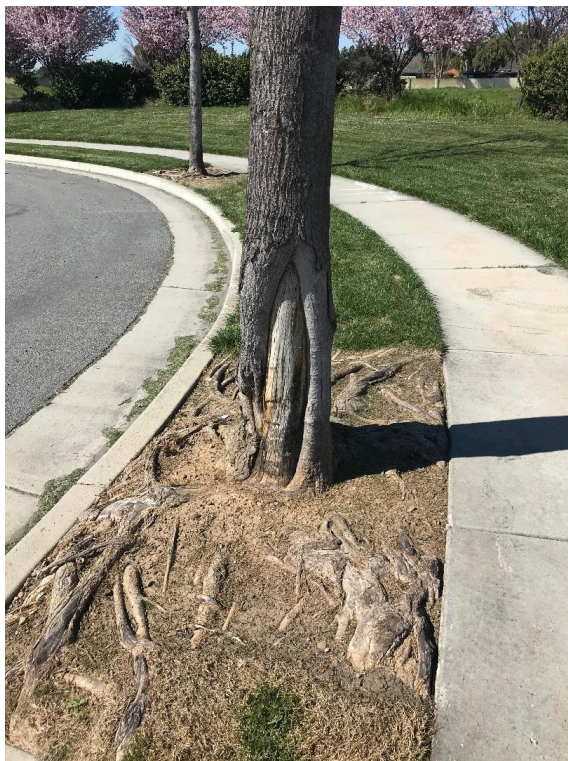
The majority of the surveyed tulip street trees were given poor condition ratings due to decay observed at the root crown and on the tree trunks. In the past turf was installed all the way up to the tree trunks. The turf has been cut with a lawn mower, and has caused significant damage to surface roots. The damaged surface roots have decayed back to the tree trunks in some cases. Decay at the root crown can significantly impact the tree structural stability. The tulip trees with condition ratings under 50 are recommended to be removed and replaced. Mulch should be placed at least 5 feet from the base of any new tree to be planted in order to avoid root damage this close to a tree trunk.

Showing decay and root damage caused by a lawn mower

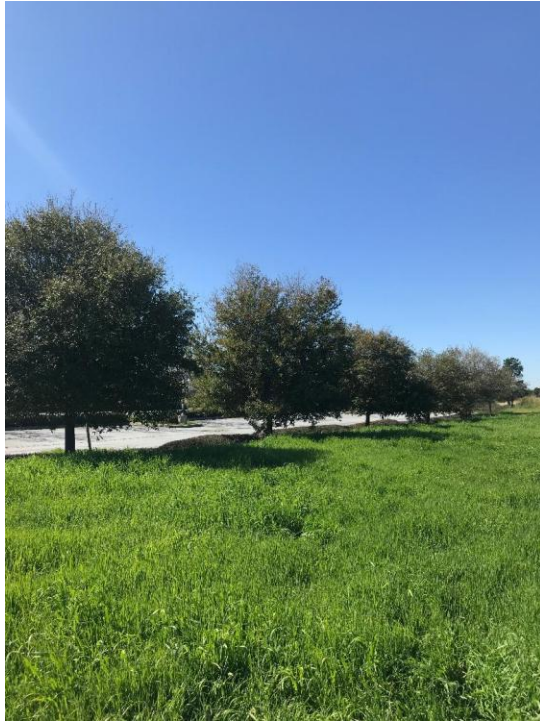
Trees #17-25 consist of southern live oak trees. These trees are all in fair to good condition. These trees act as a good screen at the property line. Tree protection fencing for these trees is recommended to be placed as close as possible to the proposed parking lot. Because these trees are young they are able to handle minor impacts. This species prefers minor irrigation during the dry season. It is recommended to irrigate these trees every 2 weeks during the dry season.

Showing southern live oak trees

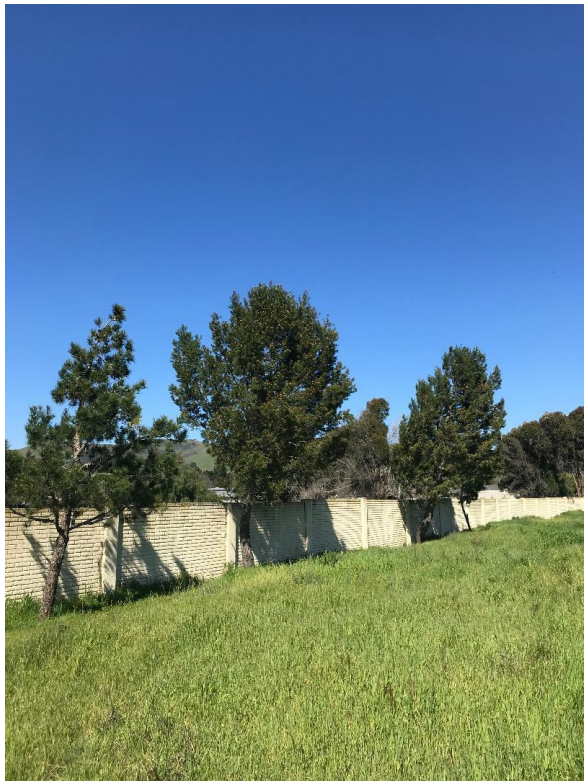
Trees #26-31 consist of Monterey pine trees at the property line. Pine tree #26 is the only pine tree to be retained. The other pine trees are proposed for removal to facilitate construction of the parking lot. Fencing should be placed at the dripline of the retained pine tree. The following tree protection plan will help reduce impacts from the planned construction.

Showing Monterey pine trees
